# Manhole Inspection Summary

Manhole # S13Q\_\_016MH

Insp Date: **3/17/08 9:04 AM**

**Location** Address: **534 S Longwood ST**

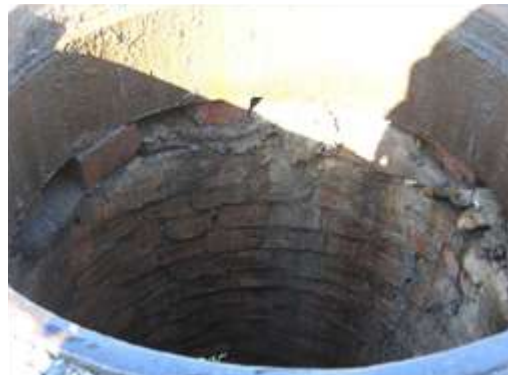
Defect 4

**Frame** Offset: **0** (in.) Condition: ☐ Sound ☐ Cracked ☒ **Leaks**

Condition: ☐ Sound ☐ Cracked ☐ Root Intrusion ☒ **Loose Brick** ☐ Deteriorated

missing/loose bricks mortar at chimney, frame leaks

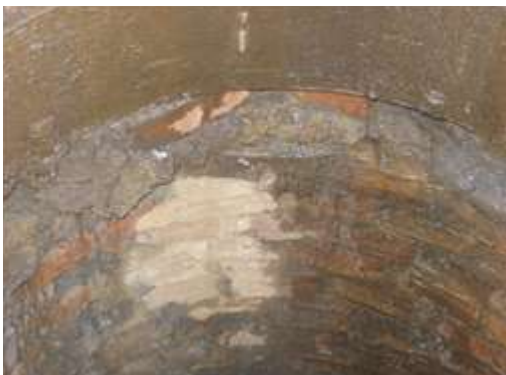
Defect 3

Infiltration: ☐ None ☐ Joint ☐ Cracks ☐ Mortar ☐ Roots ☒ **Wall**

signs of infiltration at wall of chimney and corbel

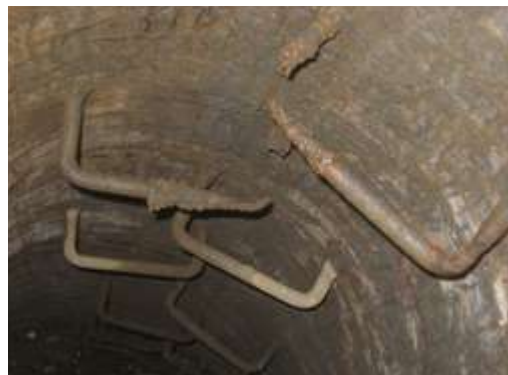
Defect 2

Infiltration: ☐ None ☐ Joint ☐ Cracks ☐ Mortar ☐ Roots ☒ **Wall**

**Steps** Count: **9** Missing: **0** ☒ **Corroded**

corroded steps and evidence of infiltration in barrel wall

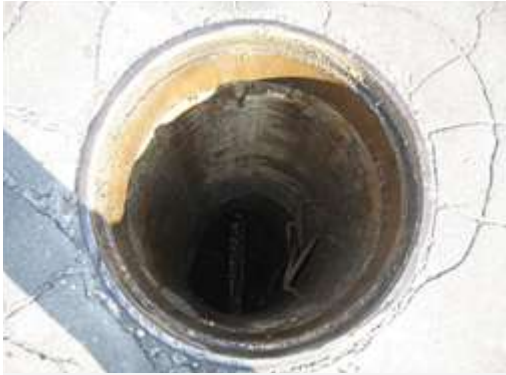
Defect 5

frame leaks

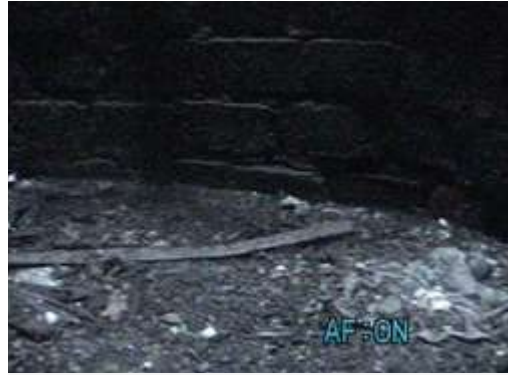
Defect 1

Condition: ☐ Sound ☐ Cracked ☐ Root Intrusion ☐ Deteriorated ☐ Leaks ☒ **Debris**

debris on bench

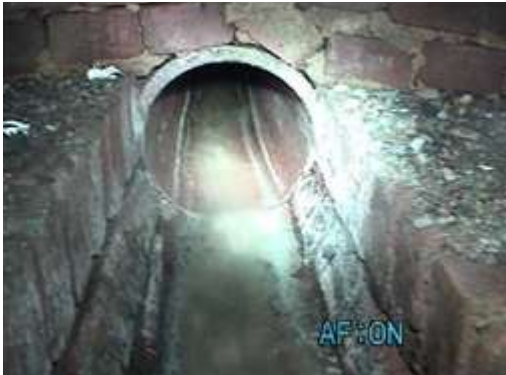
Defect 6

barrel cond loose bricks

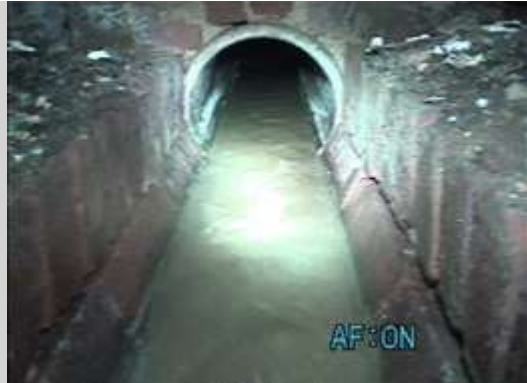
12 O'Clock Outflow

Pipe Height: **8.4** (in.) Rod and Bar (Angled)  
Pipe Material: **Clay** ☐ Pipe Lined  
Invert Depth: **16.62** (ft.) Flow Characteristics: **Fast**  
Deposits: ☒ None ☐ Mud ☐ Sludge ☐ Debris ☐ Grease  
Silt Depth: **0** (in.) Deposits Extent:  
Infiltration: **None** Pipe Seal Cond: **Sound**

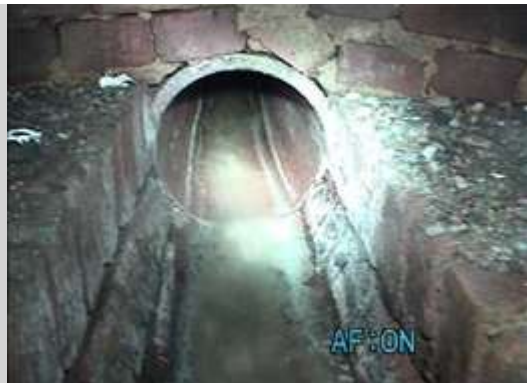
6 O'Clock Inflow

Pipe Height: **8.4** (in.) Rod and Bar (Angled)  
Pipe Material: **Clay** ☐ Pipe Lined  
Invert Depth: **17.12** (ft.) Flow Characteristics: **Fast**  
Deposits: ☒ None ☐ Mud ☐ Sludge ☐ Debris ☐ Grease  
Silt Depth: **0** (in.) Deposits Extent:  
Infiltration: **None** Pipe Seal Cond: **Sound**
